PAVING THE WAY

PAVEMENT CONDITION SURVEY

STAMFORD - 2009

Stamford Civic Society
P O Box 205
Stamford
Lincolnshire PE9 4YS

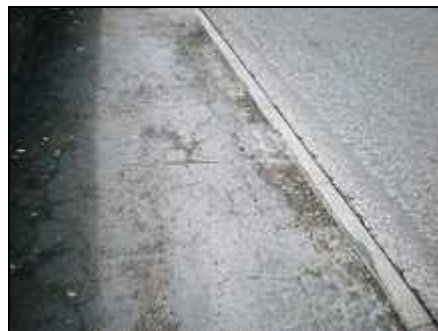
1. Rutland Terrace: the pavement adjoining Austin Friars field is in a very poor condition and needs to be completely resurfaced with tarmac along its whole length.

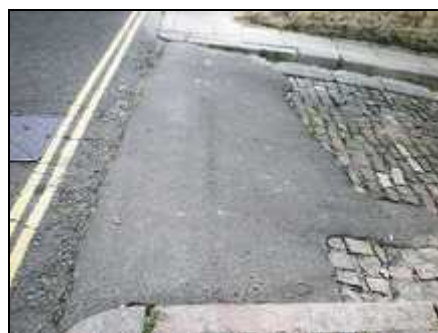
2. King's Mill Lane: tarmac at the junction spills over from St. Peter's Street – this should be replaced with matching granite blocks to blend in to the existing surface in King's Mill Lane. (Several of the blocks are covered with tarmac).

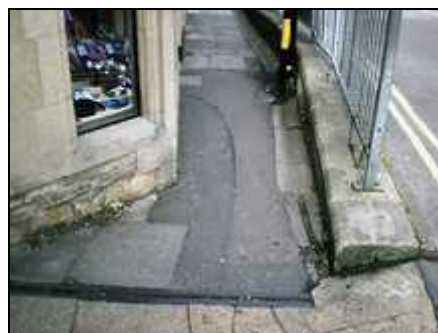
3. Castle Street: adjoining Paul Richman and near Bugle Lane; poor appearance in a sensitive area – the pavement is tarmac for c.6m and needs to be replaced with slabs to blend in with the nearby slab surface.

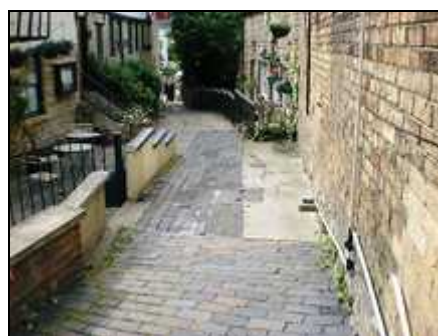
4. Old Barn Passage: there is a mix of materials used in this important historic footpath; the path has been patched up over the years using a variety of materials. This needs to be resurfaced with a consistent use of materials (e.g. granite blocks, paving slabs).

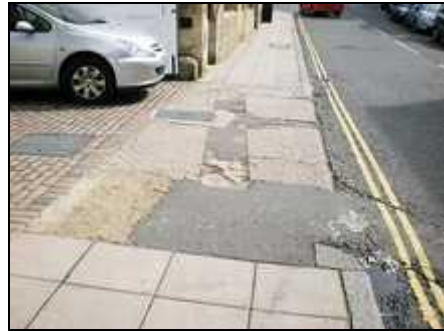
5. All Saints Street: cross-over access to the Brewery is in very poor condition, patched with concrete and other materials. This is a high profile site in the town centre and needs to be replaced with granite blocks to blend with the Brewery forecourt.

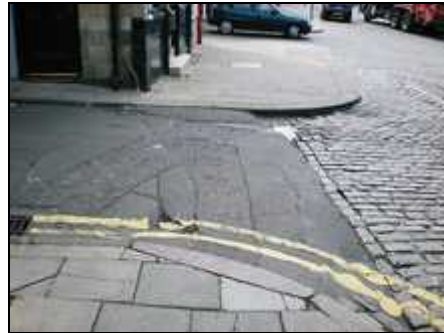
6. Crown Street: at junction with All Saints Place - access to pedestrian crossover is crudely executed with a tarmac ramp to the kerbstone. It should be re-laid to a higher standard and with a properly graded slope to street level.

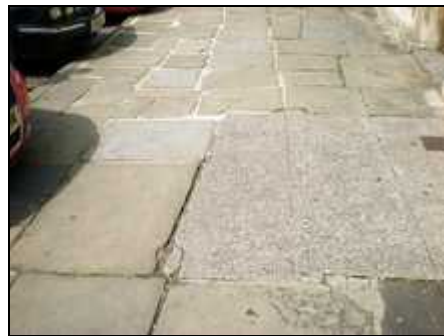
7. Broad Street: north side, adjoining Nos. 6-8; the pavement grouting is of very poor quality, plus pre-cast slabs used in places – it needs to be re-grouted and the concrete slabs replaced with proper paving slabs.

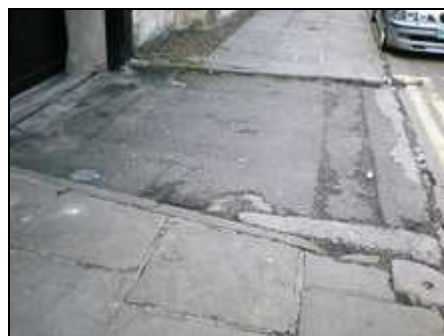
8. Broad Street: south side at No. 32 cross-over access to private garage; poor quality patchwork of tarmac and concrete needs to be re-surfaced with a consistent use of material (e.g. granite blocks).

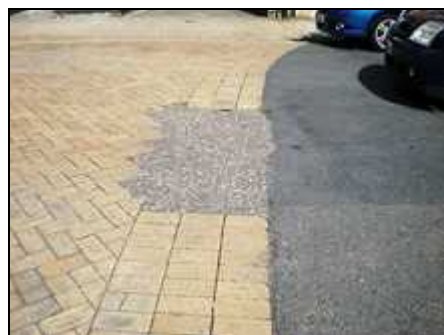
9. High Street: east end near Marks and Spencer; large area where the bricks have been replaced with concrete filler – the bricks need to be reinstated.

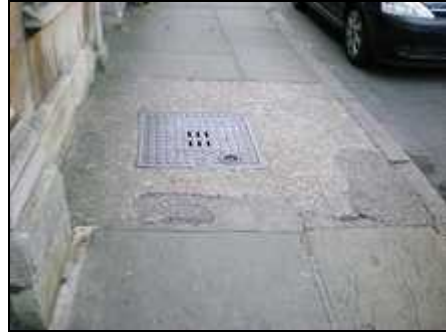
10. St Mary's Street: outside the Arts Centre; the surface needs to be replaced around the BT cover with paving slabs (as far as possible) consistent with the rest of the pavement.

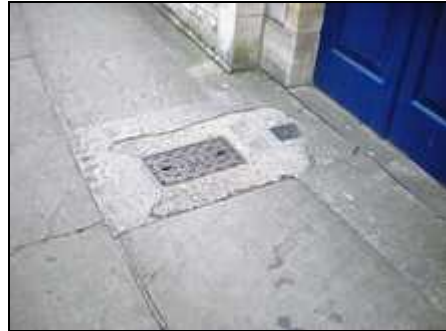
11. St Mary's Street: near to item 10 above; the concrete surround to the fire hydrant needs to be replaced with paving slabs.

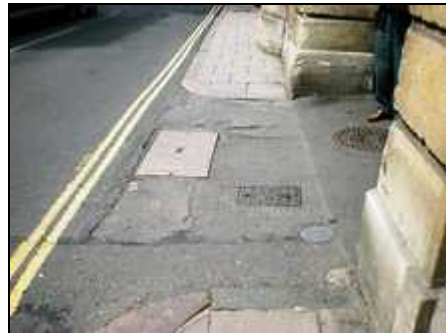
12. St Mary's Street: opposite St Mary's Church at the entrance to Stamford Walk; very poor quality repairs to the surface with a mix of materials, with four service covers in this small area. This should be replaced with granite blocks.

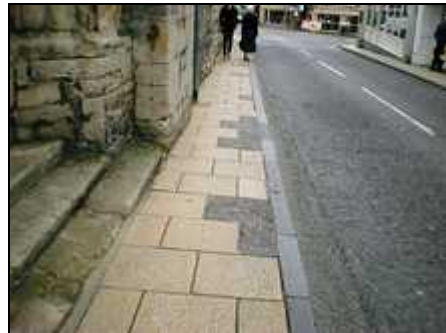
13. St John's Street: east side adjoining church wall; fourteen places where paving slabs have been replaced with tarmac, the paving slabs need reinstating.

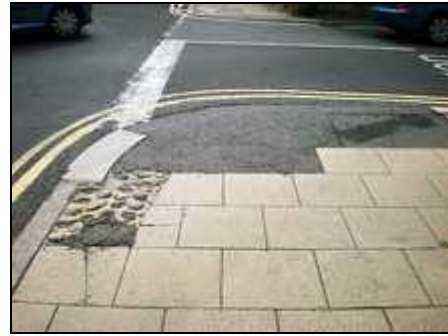
14. High Street St Martin's: junction with Kettering Road, north side; five or six kerbstones missing, tarmacked with two different types and some remains of pebbled concrete; no indication of kerb edge making it extremely unsightly and dangerous for pedestrians. It needs new kerbstones and to be re-covered with paving slabs to match those existing.

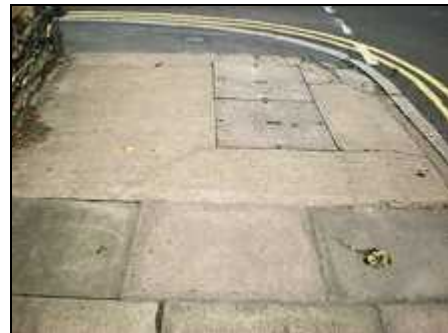
15. High Street St Martin's: south side; concrete and tarmac needs replacing with paving slabs as above.

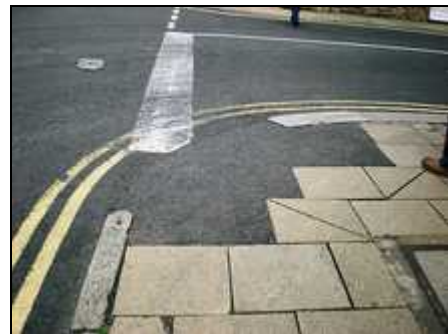
16. High Street St Martin's: junction with Barnack Road, south side; two or three kerbstones missing and missing paving slabs replaced by tarmac, paving slabs and kerbstones need re-instating.

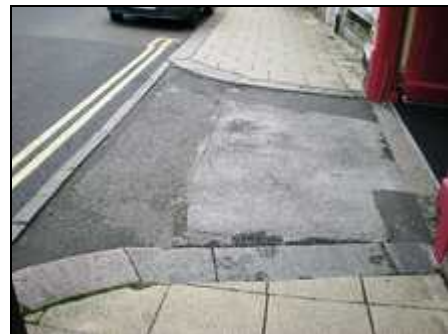
17. High Street St Martin's: cross-over access to St Martin's Antiques; resurfaced with about five different types of tarmac making it most unsightly; needs to be resurfaced consistent with the location (e.g. granite blocks).
