LAND EAST OF ALBERT BRIDGE

LAND WEST OF ALBERT BRIDGE

Water Steet Gardens
Proposed tree removals/works
 following site visit 15/03/2018 with Peter Glassey,
 Head Forester at Burghley House Preservation Trust
 Scale 1:500 @ A3

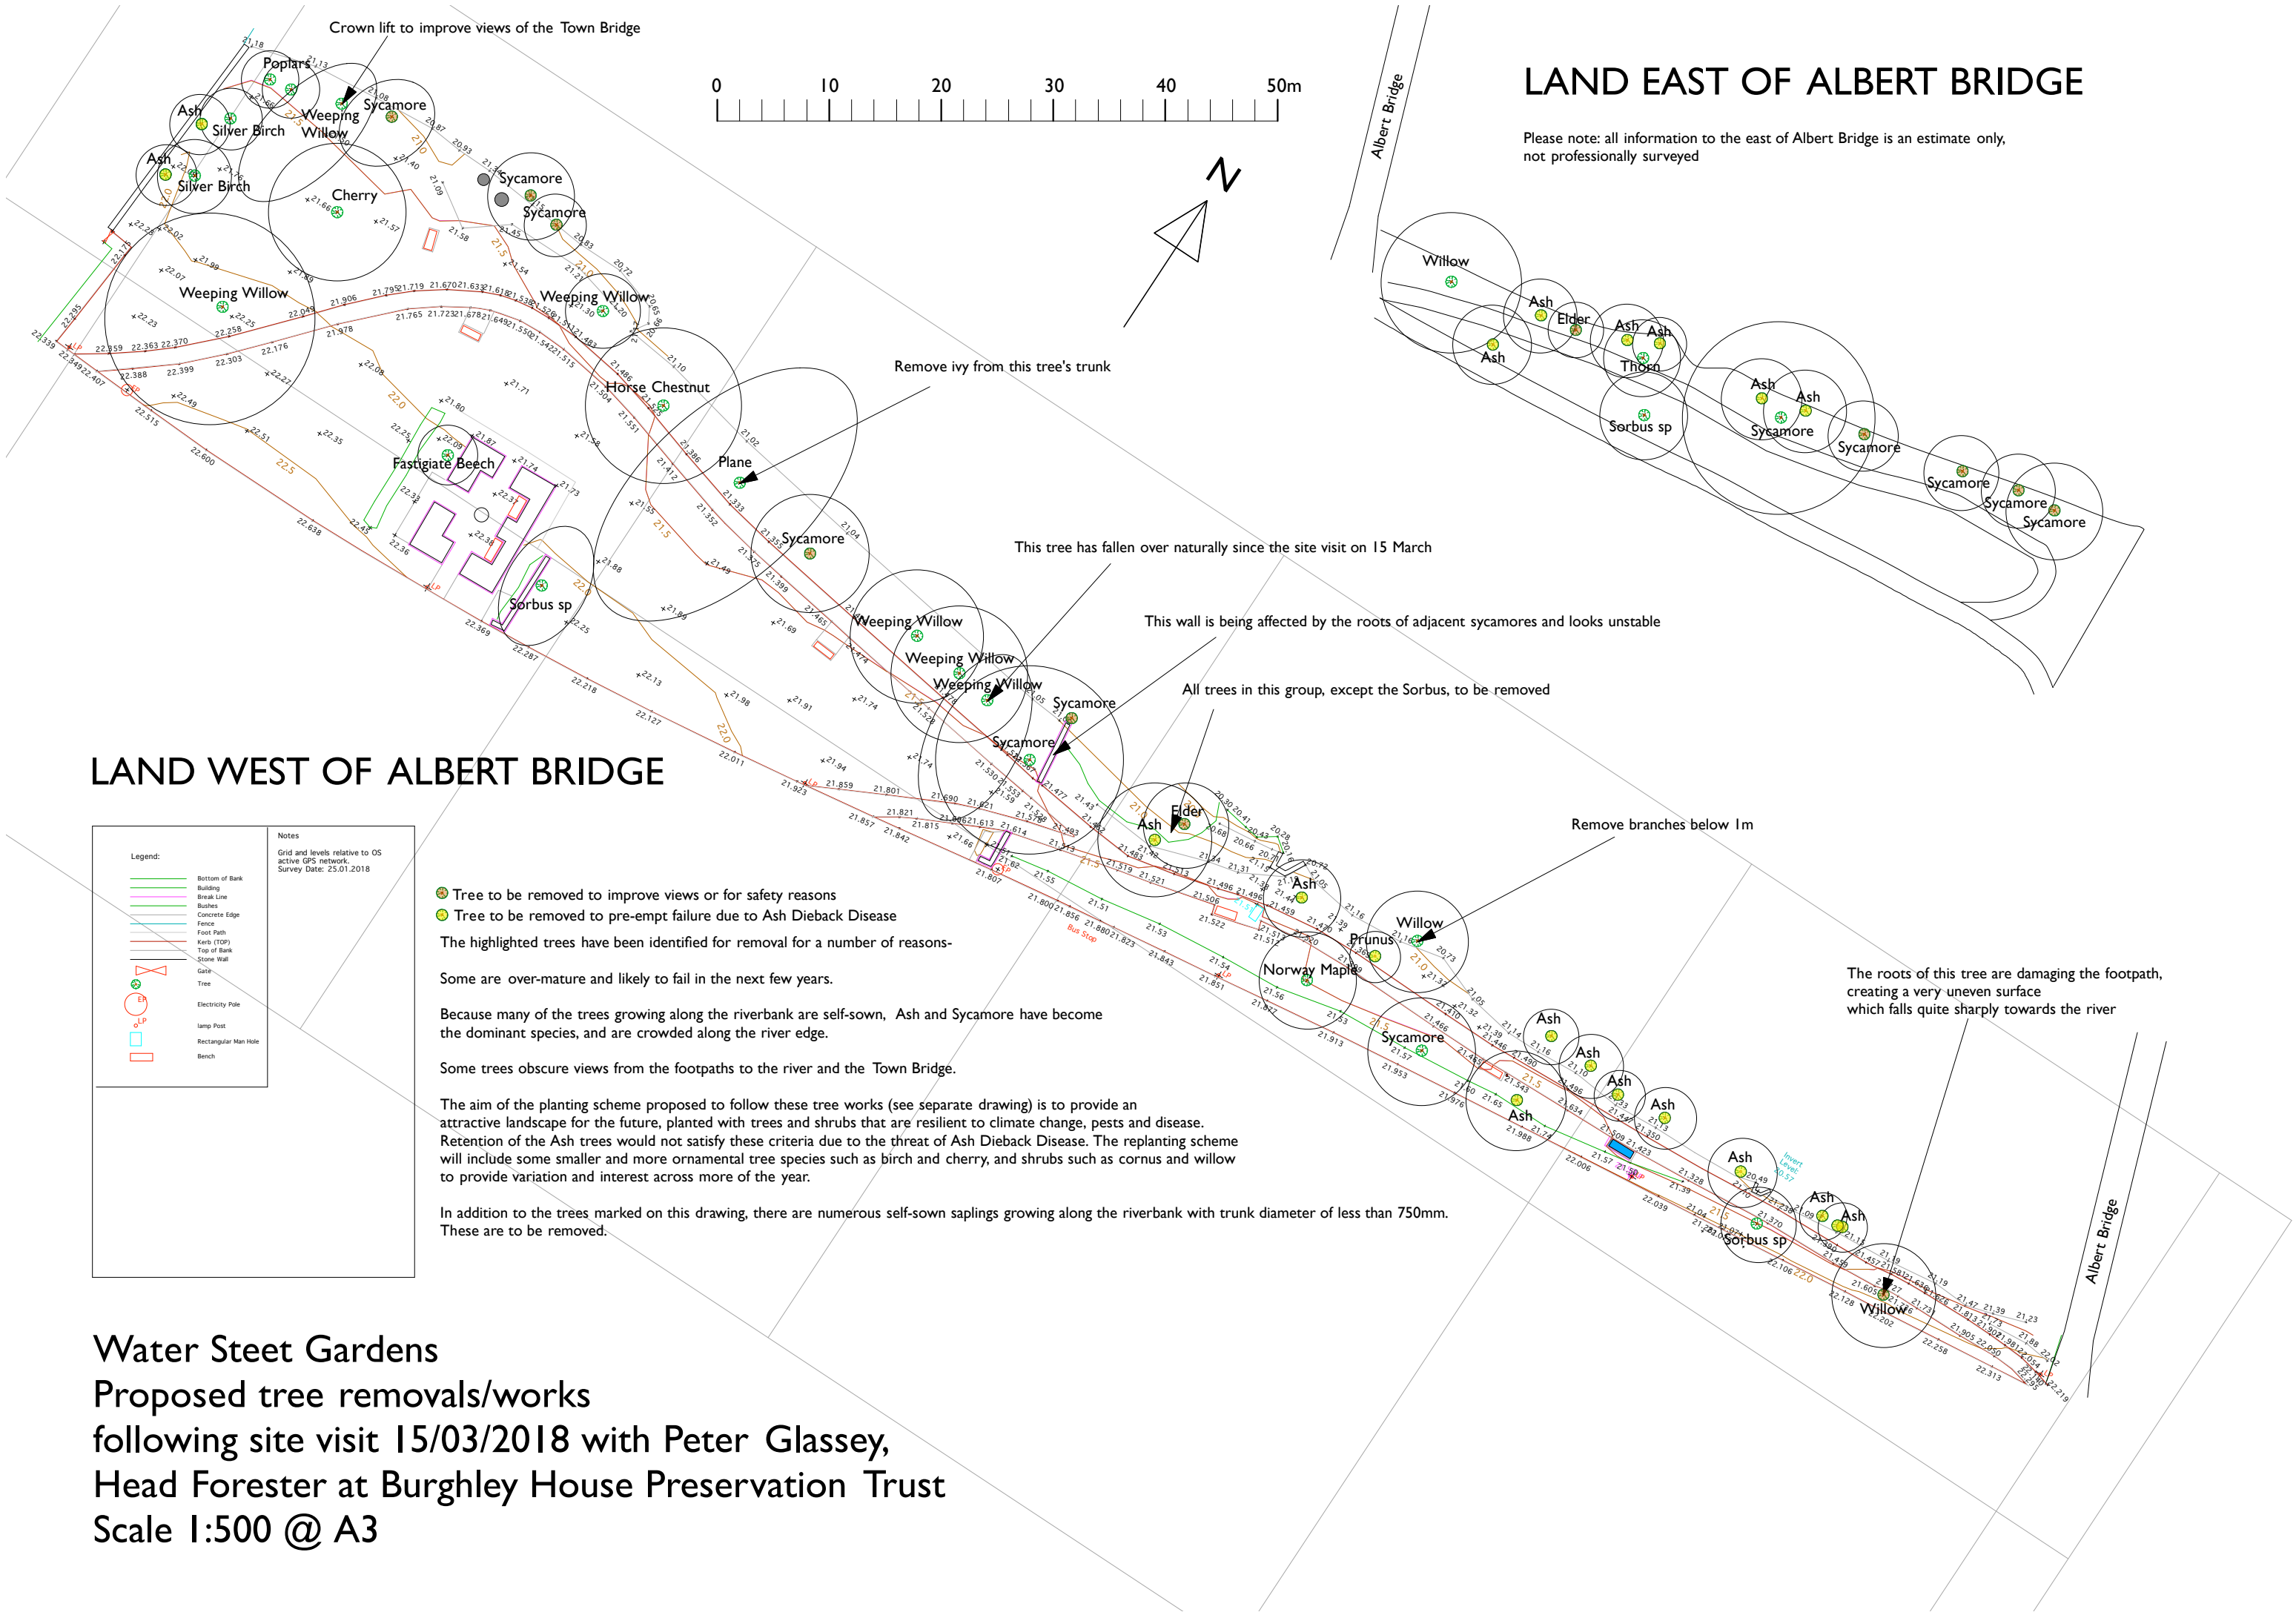
- Tree to be removed to improve views or for safety reasons
- Tree to be removed to pre-empt failure due to Ash Dieback Disease

The highlighted trees have been identified for removal for a number of reasons-

Some are over-mature and likely to fail in the next few years.

Because many of the trees growing along the riverbank are self-sown, Ash and Sycamore have become the dominant species, and are crowded along the river edge.

Some trees obscure views from the footpaths to the river and the Town Bridge.

In addition to the trees marked on this drawing, there are numerous self-sown saplings growing along the riverbank with trunk diameter of less than 750mm. These are to be removed.

The aim of the planting scheme proposed to follow these tree works (see separate drawing) is to provide an attractive landscape for the future, planted with trees and shrubs that are resilient to climate change, pests and disease. Retention of the Ash trees would not satisfy these criteria due to the threat of Ash Dieback Disease. The replanting scheme will include some smaller and more ornamental tree species such as birch and cherry, and shrubs such as cornus and willow to provide variation and interest across more of the year.
